Quality Assurance and Source Inspection

Contract #: 04-0120F4Cty: SF/ALA Rte: 80 PM: 13.2/13.9File #: 1x.28**WELDING INSPECTION REPORT****Resident Engineer:** Casey, William**Address:** 333 Burma Road**City:** Oakland, CA 94607**Report No:** WIR-027495**Date Inspected:** 23-Apr-2012**Project Name:** SAS Superstructure**OSM Arrival Time:** 700**Prime Contractor:** American Bridge/Fluor Enterprises, a JV**OSM Departure Time:** 1730**Contractor:** American Bridge/Fluor Enterprises, a JV**Location:** On Site**CWI Name:** Bernie Docena**CWI Present:** Yes No**Inspected CWI report:** Yes No N/A**Rod Oven in Use:** Yes No N/A**Electrode to specification:** Yes No N/A**Weld Procedures Followed:** Yes No N/A**Qualified Welders:** Yes No N/A**Verified Joint Fit-up:** Yes No N/A**Approved Drawings:** Yes No N/A**Approved WPS:** Yes No N/A**Delayed / Cancelled:** Yes No N/A**Bridge No:** 34-0006**Component:** SAS OBG Components**Summary of Items Observed:**

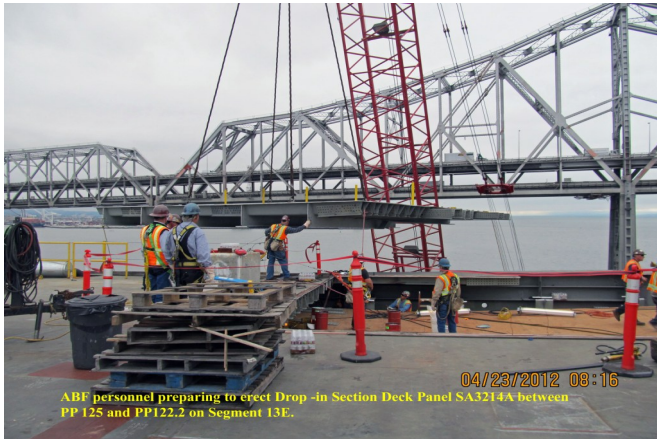
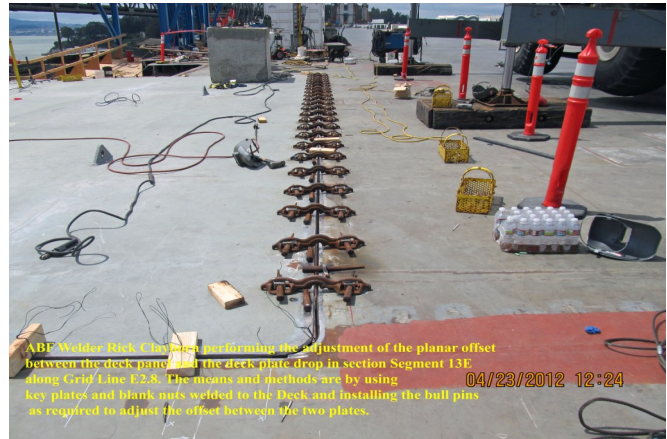
Afterwards, this QA Inspector observed ABF Welder Rick Clayborn performing the fillet weld operation per the Shielded Metal Arc Welding (SMAW) process in the (2F) horizontal position connecting the blank nuts to the deck plate for installation of the key plates to adjust the longitudinal weld splice planar offset between the Deck Plate section and Deck Plate Drop-in section along Grid E2.8.

This QA Inspector observed that ABF welder Rick Clayborn was in-process fillet welding the blank nuts to the Deck Plate section and Deck Plate Drop-in section along Grid E2.8 at the end of this QA Inspectors' shift.
